**Third Coast Home  
Inspection**  
8906 Ampezo Trail  
Austin, TX 78749

## PROPERTY INSPECTION REPORT

By: Craig A Boarini, Lic #10498 06/13/2017  
(Name and License Number of Inspector) (Date)

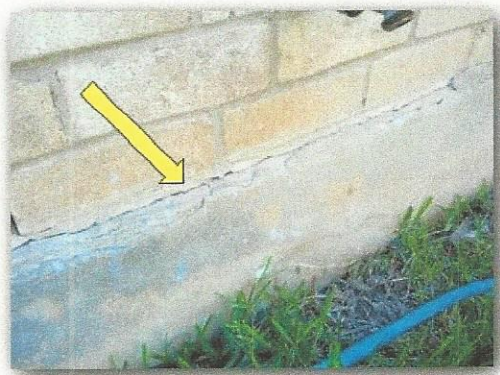
- ☒ Seal seams between the foundation and the stone/brick veneer and any corner pops with a color matching waterproof caulk to keep moisture and bugs out.
- ☒ Cracks in brick, stone, or stucco
- ☒ Floors not level

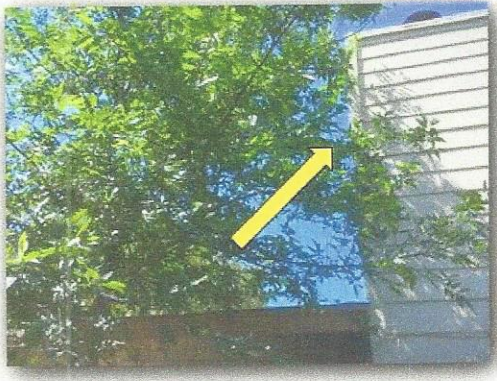
- ☒ Cut Trees/bushes away from the house and roof to keep moisture, bugs, rodents and damage

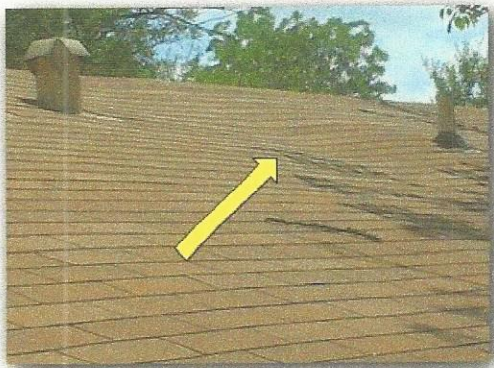
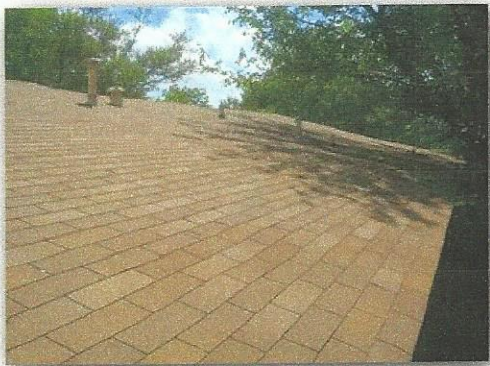
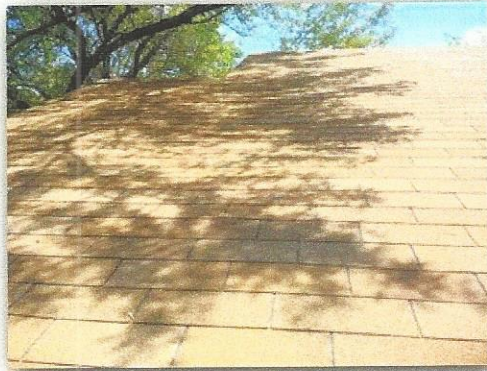
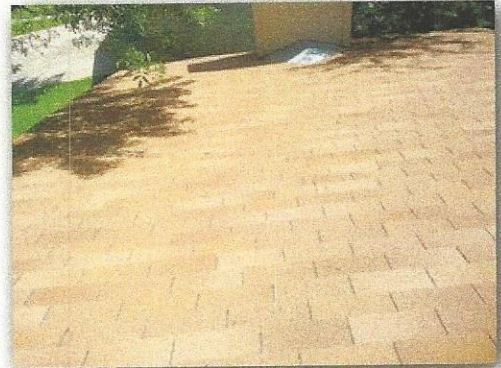
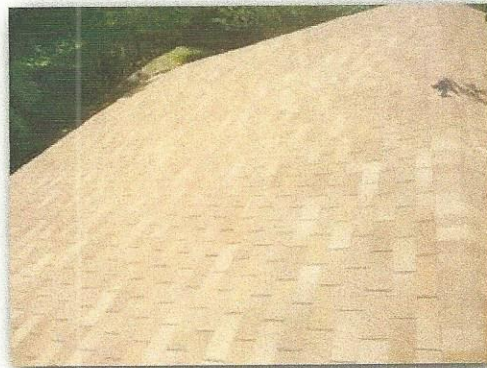
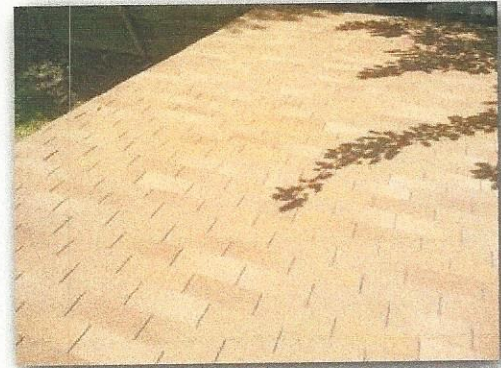
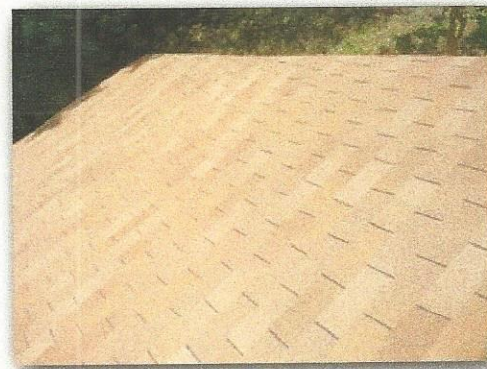
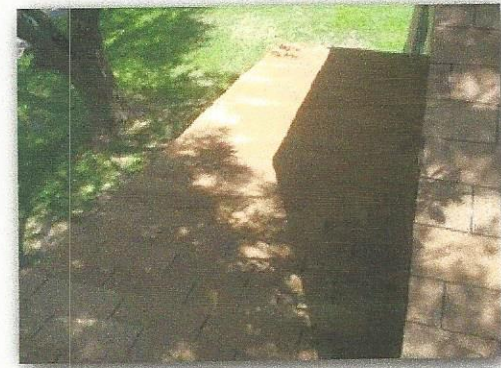
☒ Sag in roof sheeting., broken rafters viewed from attic - Have checked and repaired as needed by a certified roofer.

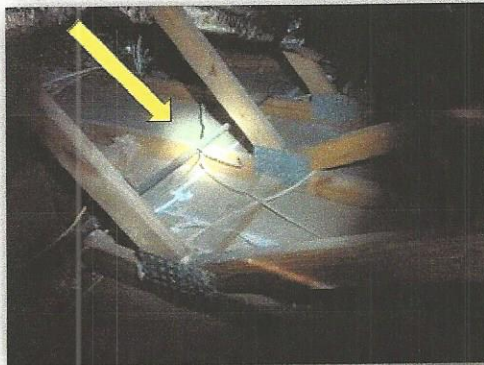
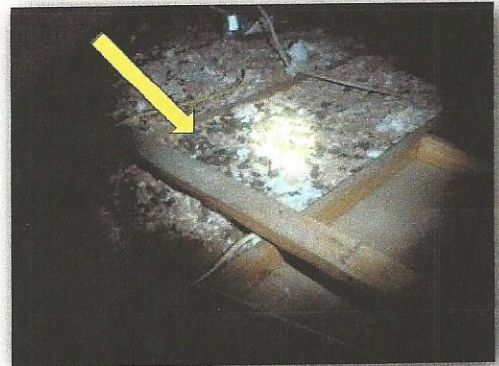
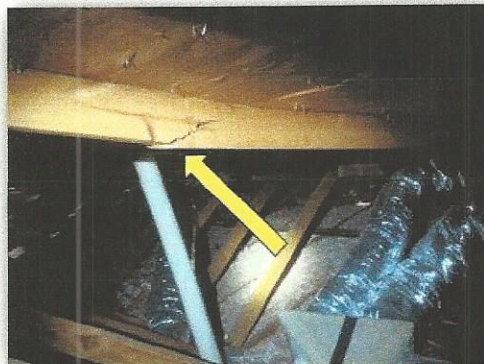
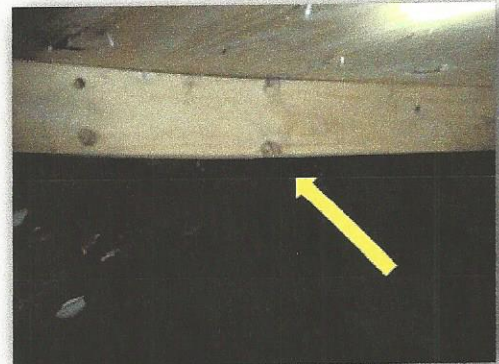
☒ Broken roof rafters visible in the attic.

- ☒ Evidence of insulation voids in the attic.
- ☒ More insulation should be added to the attic
- ☒ Evidence of animal intrusion in the attic. (Have inspected by a pest control company to determine the amount of damage and if insulation replacement is needed.)

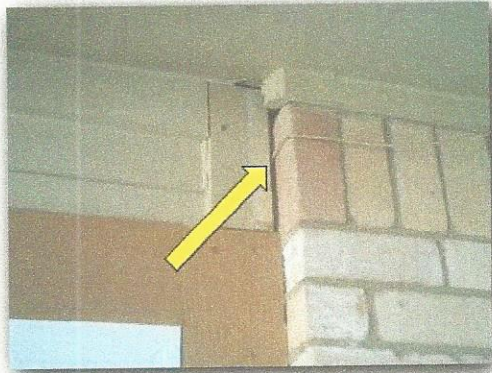
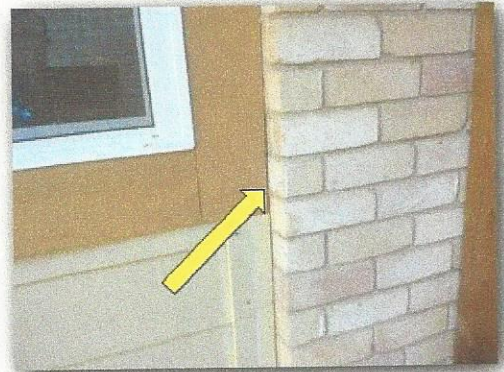
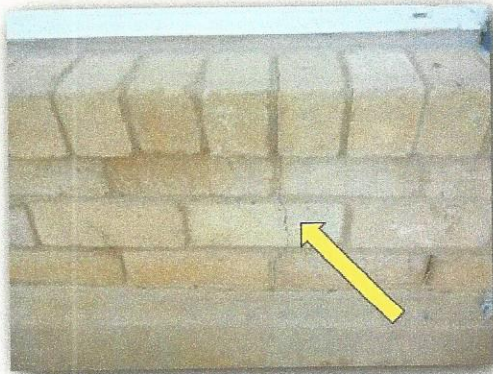
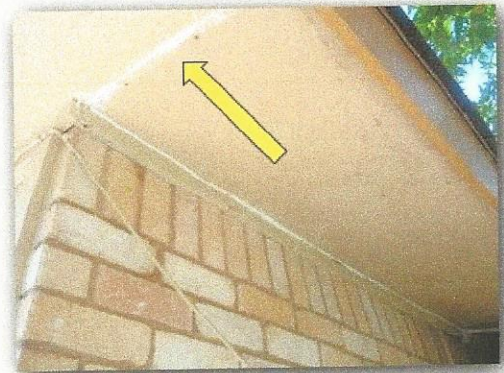
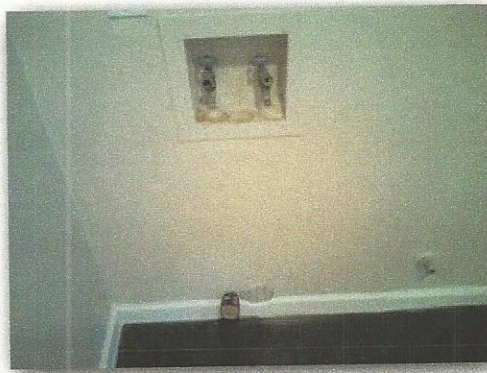
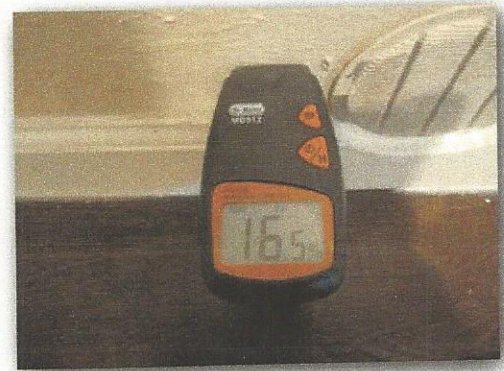
- ☒ Minor water leak from laundry connection, 16.5 % moisture reading.
- ☒ Freshly Painted

- ☒ Incomplete sealing and painting of exterior siding and trim in various locations.
- ☒ Settlement cracks present in exterior brick/stone/stucco should be sealed with a color matching water proof caulk to keep water and bugs out. And monitored to insure no future

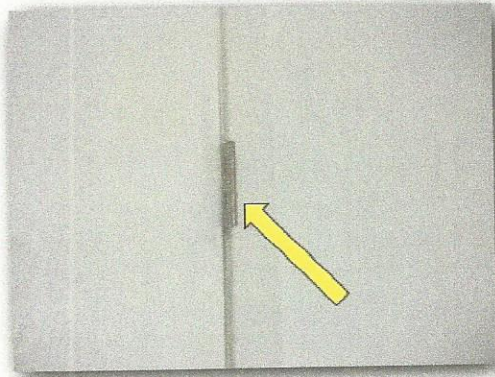
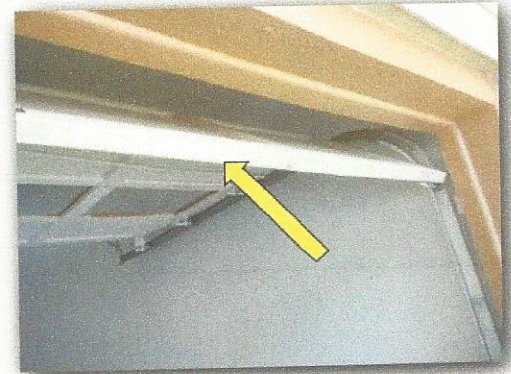
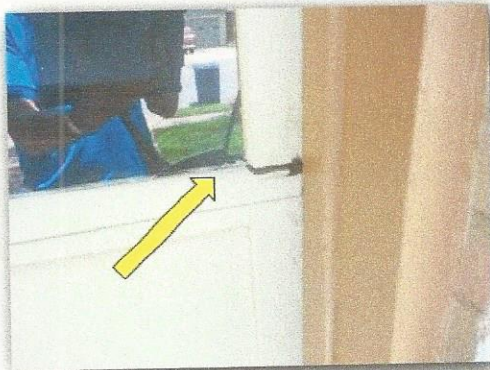
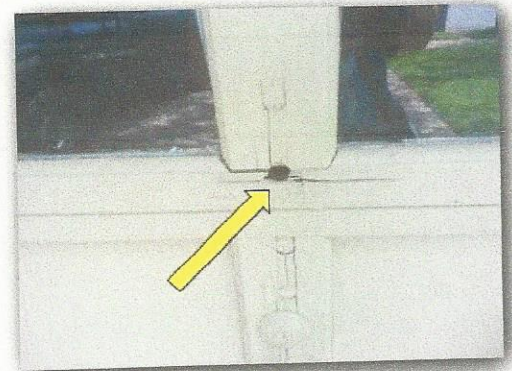
- ☒ Door between living area and garage is missing auto closing hinges. - Safety Hazard

- ☒ Outer garage door deteriorated and window broken.  
☒ Sliding screen door is missing  
☒ Outer garage door bottom door seal is missing.

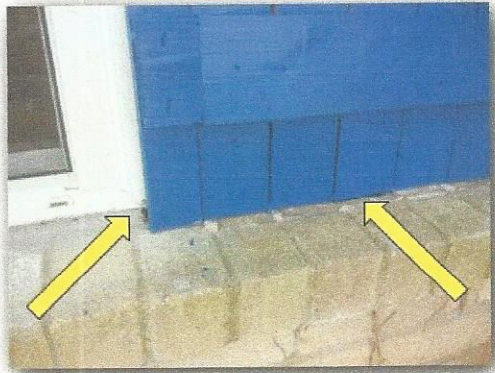
- ☒ Caulking touch up needed for the exterior brick/stone/other window surrounds to keep wind, water, and bugs out.

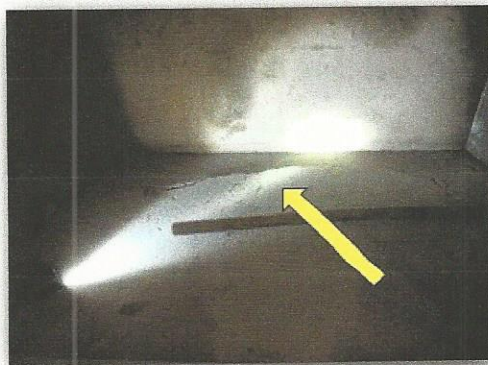
☒ Fireplace firebox floor is cracked - Safety hazard.

☒ Fireplace flue is dirty - Safety hazard (Have checked and cleaned by a certified chimney sweep)

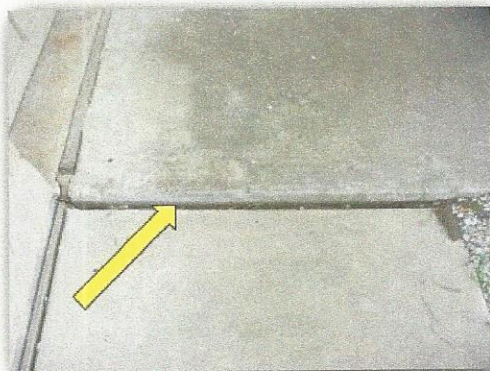
☒ Front walk has settled/lifted creating a trip hazard.

☒ Fence gate is damaged/drags on the ground

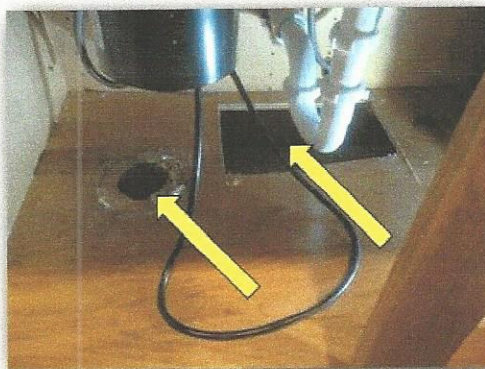
- ☒ Kitchen sink cabinet floor needs repair.
- ☒ Door bell/door knocker missing

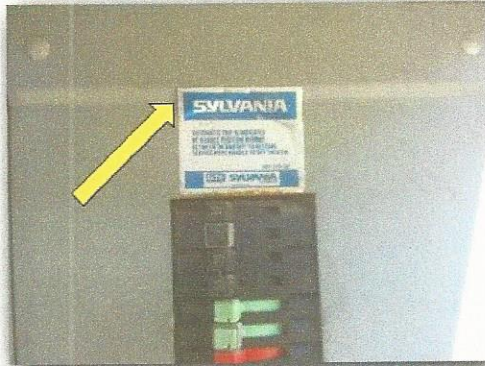
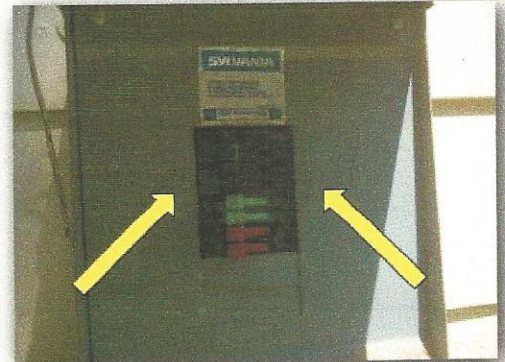
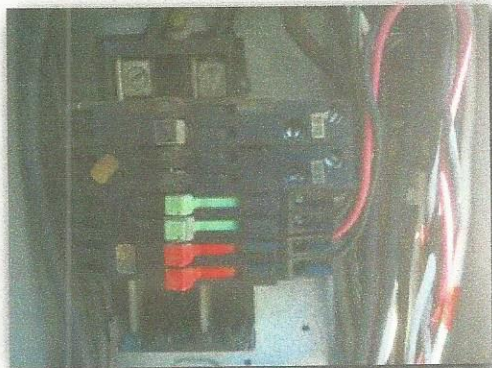
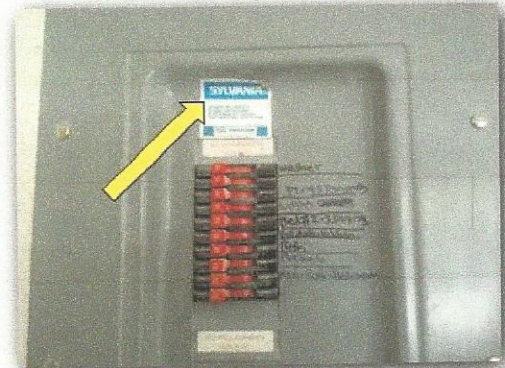
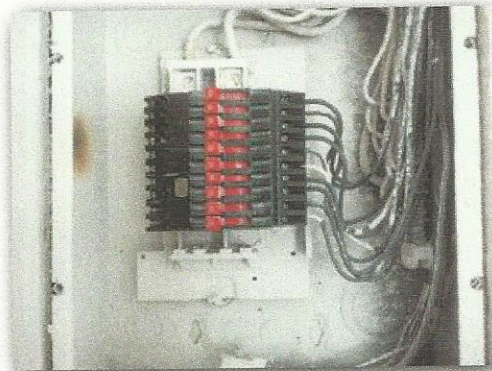
- ☒ Size unknown.
- ☒ Main electrical panel is not labeled - Safety hazard
- ☒ Main or sub electric panel is a Federal Pacific, or Zinsco Brand panel and are a known fire hazard. (No scorching was present at the time of inspection)

Specifies max amp breaker of 30 amp\_ and a ??? amp breaker is in use

☒ No ARC fault breakers present for the bedroom - Not required at the time of construction.

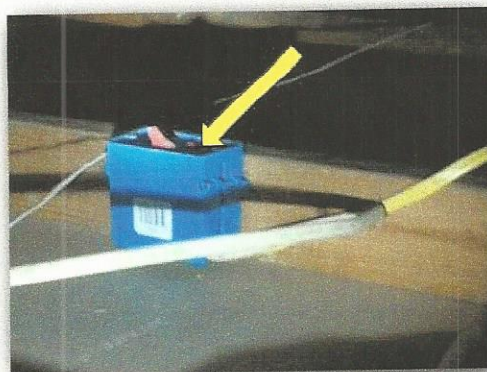
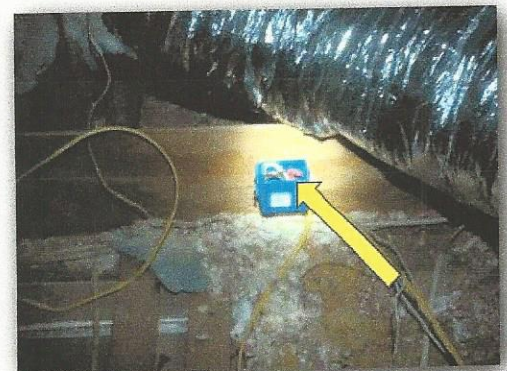
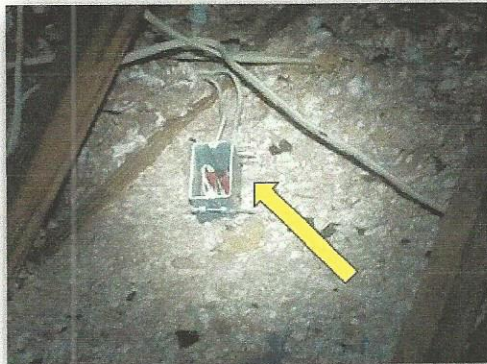
☒ One or more electrical junction boxes do not have covers and are not anchored - Safety hazard

☒ No GFCI/ARC Fault protection at one or more location. This is considered a recognized safety hazard. Exterior, Laundry

☒ Not working smoke alarm in hallway

☒ Missing Carbon Monoxide detectors when gas supply is present on the property - Safety Hazard

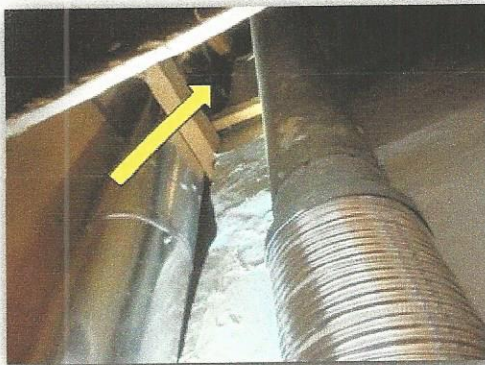
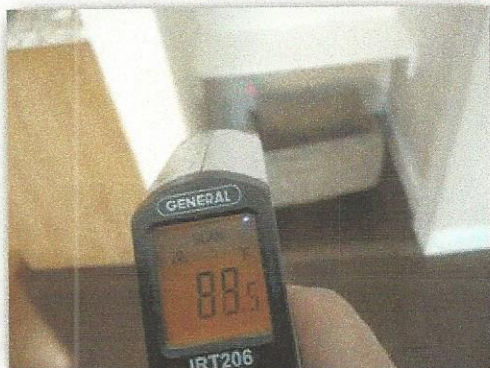
*Comments:* Furnace starts up then shuts itself done, Have checked and repaired as needed by a certified HVAC tech.

☒ Furnace closet is open to the attic - Safety hazard

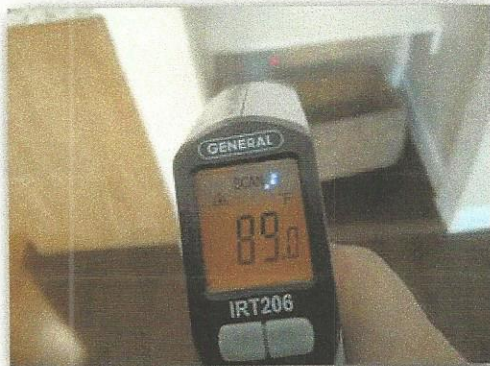
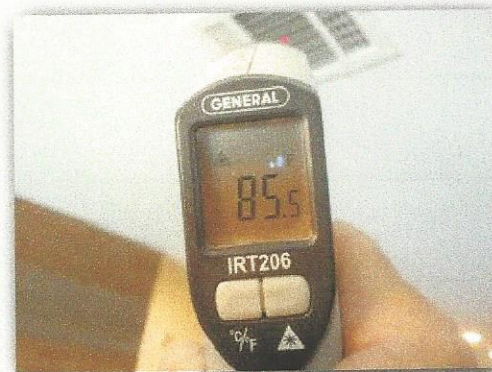
*Comments:* 3 ton, age unknown. A/C was not performing within the correct temperature differential of 14 to 23 degrees difference between the supply and return air at the time of inspection. (Have checked and repaired as needed by a certified HVAC tech).

Temp. Differential: 04 °F

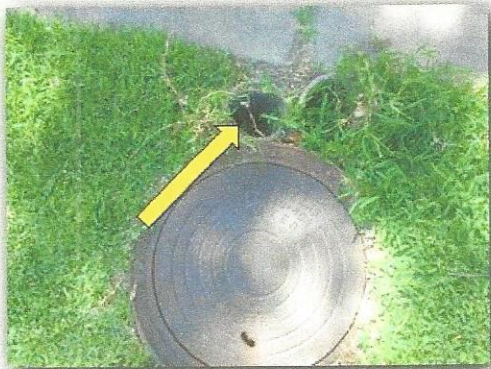
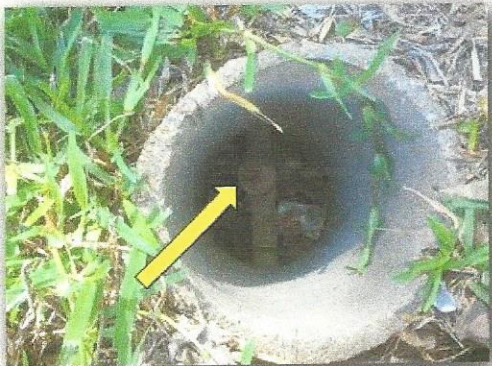
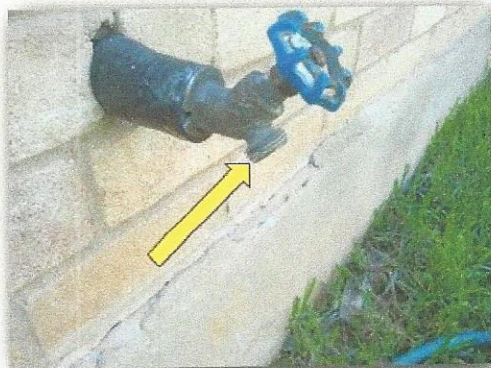
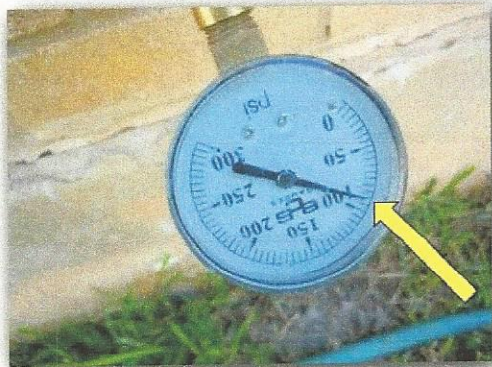
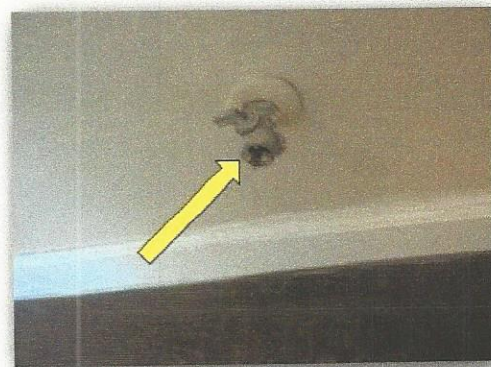
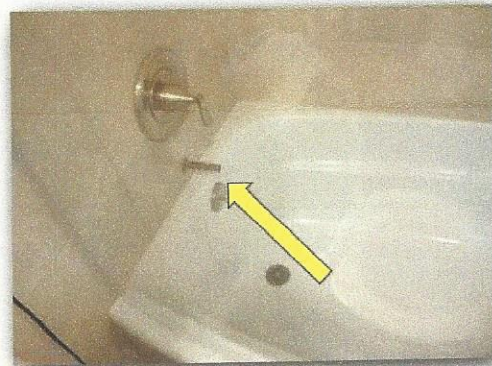
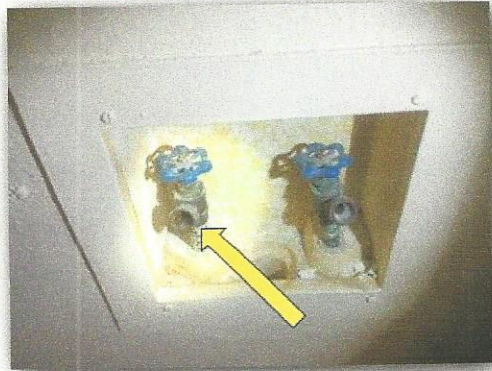
☒ Water pressure is at 90 psi (normal is between 40 and 80 psi). A water pressure reducer should be install and the pressure turned down to within a safe range.

☒ Home owners shut off valve is missing a handle and a cover.

☒ Sink stopper missing/damaged or not working in bathroom sinks. - Guest

☒ Master bath tub is missing spout - Not tested.

☒ Hot water washing machine hook up drips.

☒ Dryer gas valve was not capped at the time of inspection - Safety hazard

☒ Exterior water spigots do not have back-flow prevention

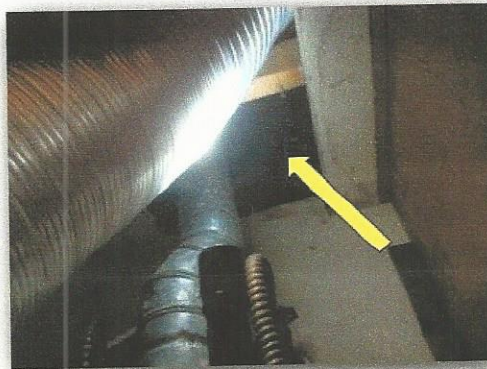
☒ Water heater is a 2003 model and is considered past it life,

☒ Water heater is open to the attic. - Safety hazard

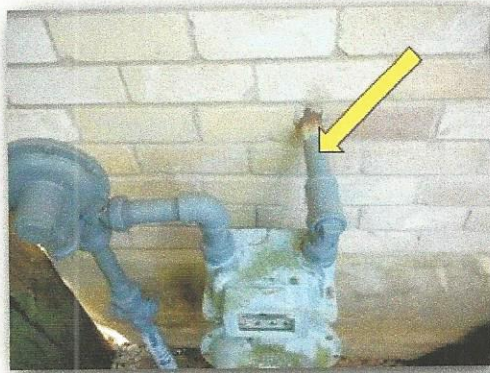
- ☒ Gas meter is not grounded - Safety hazard

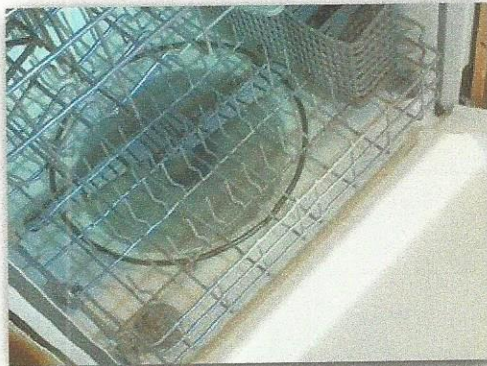
- ☒ Dishwasher doesn't drain .

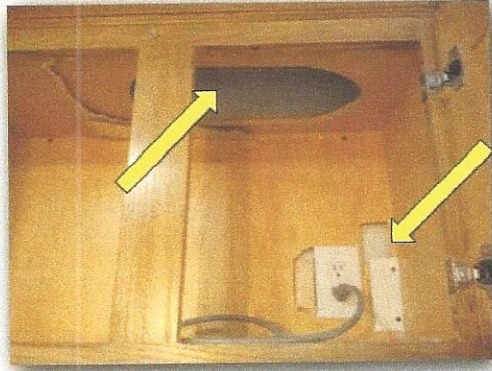
- ☒ Range hood vent not connected to anything, vents into cabinet, also construction holes in cabinet..

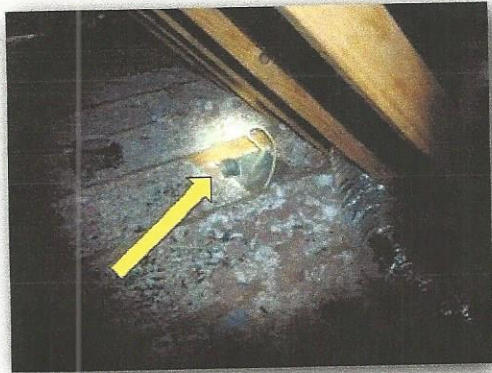
☒ Stove gas shut off appears to be behind the stove and not in a cabinet to the side. - Safety hazard

☒ Absence of anti-tilt device on the stove. - Child safety hazard

☒ Bathroom exhaust fans missing or don't vent to the outdoors.

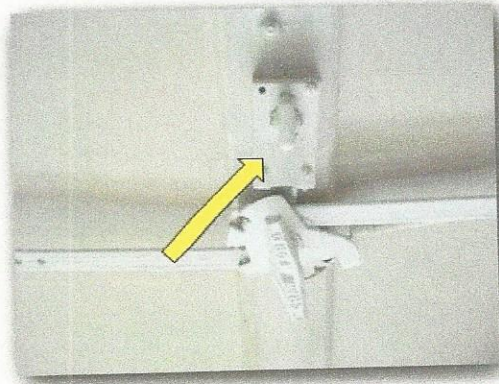
- ☒ Auto garage door openers light not working - Safety hazard
- ☒ Auto garage door openers auto reverse does not work - Safety Hazard
- ☒ Outer garage door locks have not been removed or disabled and there is an auto garage door opener present. - Safety hazard
